Item #1 Soft Housings There have been a number of reported incidents of unusually high pull forces needed to release the main canopy in a malfunction situation. The situation has been encountered on systems using soft housings and mini risers. It reportedly has only happened with malfunctioning small high performance canopies which have twisted the risers tightly before release action could be initiated.

Item #4 Strong Enterprises Bulletin Strong Enterprises issued Product Service Bulletin #22 on 20 February, 1997 which affects their Dual Hawk Tandem. This two part bulletin requires mandatory compliance prior to 20 May, 1997.

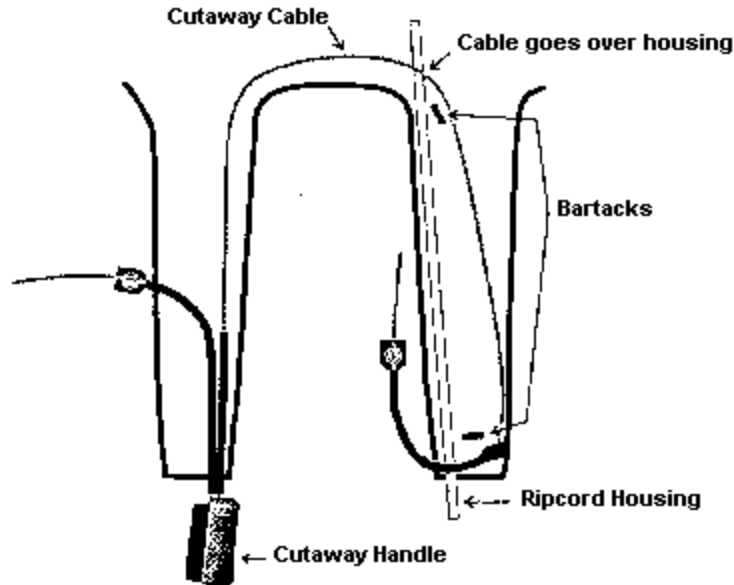
Sun Path, makers of the Javelin, have used soft housings for a number of years and continue to do so. They tend to think some of the hard pull situations could have been averted if the longer release cable had been correctly routed. A diagram follows which shows correct routing.

Soft housings can be replaced with metal housings by a qualified Rigger "A" as long as they only require hand tacking. Any required machine sewing would need to be performed by a Rigger "B". Details of housing change-over can be obtained from Sun Path Products Inc., 5037 Gall Blvd., Zephyrhills, Florida 33541 Phone: (813) 782-9242 Fax: (813) 788-3057
