CANADIAN SPORT PARACHUTING ASSOCIATION ASSOCIATION CANADIENNE DU PARACHUTISME SPORTIF

TECHNICAL BULLETIN #98

Item #1 - Icon Containers with Skyhook Installed

Item #2 – Substandard Loop Washers

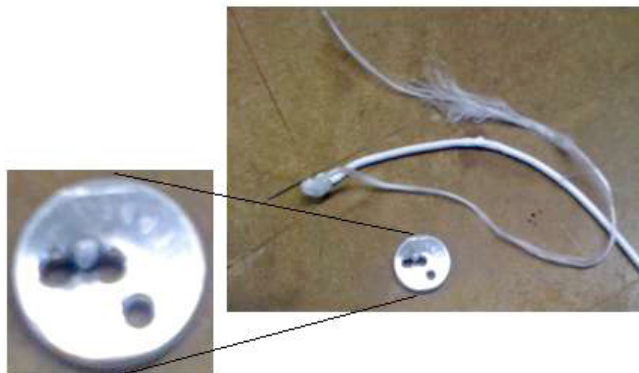
Apparently certain discs can break or rip from hole to hole. The problem has been known by the disc supplier since 2009 and according to the supplier at least 400 are still out in the field.

Due to metal fatigue, the disc can break at an unpredictable moment. A broken disc can break the reserve closing loop and cause an untimely opening of the reserve container at a critical time (e.g. floating and landing). Alternatively the damaged loop and/or washer may obstruct or delay the opening of the reserve container or hamper the reserve deployment.

All parachute systems equipped with an Argus AAD should have their disk checked and replaced after each repack. Aviacom highly recommends replacing all smiley washers with stronger steel washers using a figure 8 knot for the loop. Free steel washers will be supplied upon request to all Argus users with mentioning serial number and date of manufacture.
