**Item #1 Tandem Vector Modification**

**Item #2 Closing Loops**

**Item #3 Loose Fitting on Vectors**

**Item #5 FXC 12000 Cable Failure**

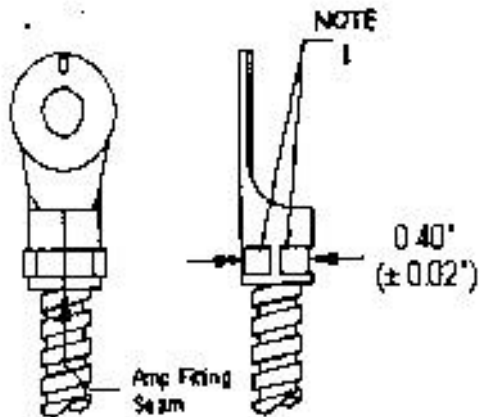
CORRECT

Note 1 - A correctly swaged AMP fitting has two semicircular indentations.

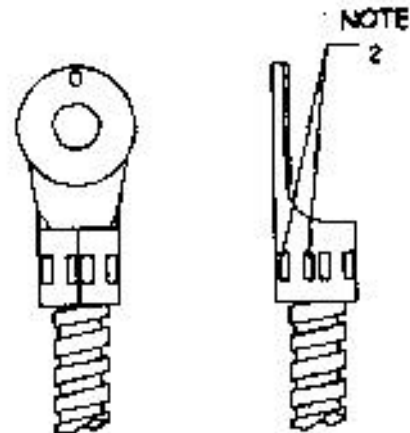
INCORRECT

Incorrectly swaged fittings may not be secure and can be twisted off using only finger pressure applied in a certain direction. This could result in the canopy release cable being activated accidentally.

Note 2 - An incorrectly swaged AMP fitting has numerous small indentations around the fitting.

Inspection may require removal of the shrink-wrap. Incorrectly swaged fittings need to be repaired immediately. Copies of SB#091098 are available from Relative Workshop.

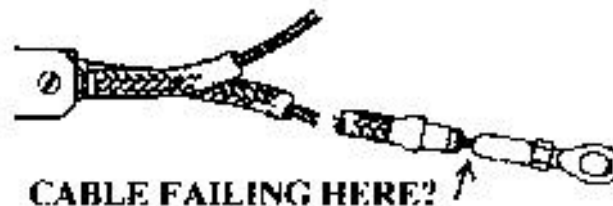
Inspections should be carried out on FXC 12000 AAD units for possible cable damage at the pin end of the operating cable. According to the FXC this problem can be avoided by proper use of the Ripcord Pin Terminal.

"The Ripcord Pin Terminal must be screwed on tight into the Ripcord Sleeve, ensuring that the cable's ball tip is secure in the sleeve and the sleeve's hole edge is over the cable's protective shoulder. If at any time the Ripcord Pin Terminal is loose, the edge of the sleeve will be moving continuously over the cable causing a cutting action on the cable resulting in frayed cable."
